Full Length Research Paper

Effect of development on the morphology of Motoine/Ngong River Channel, Kenya

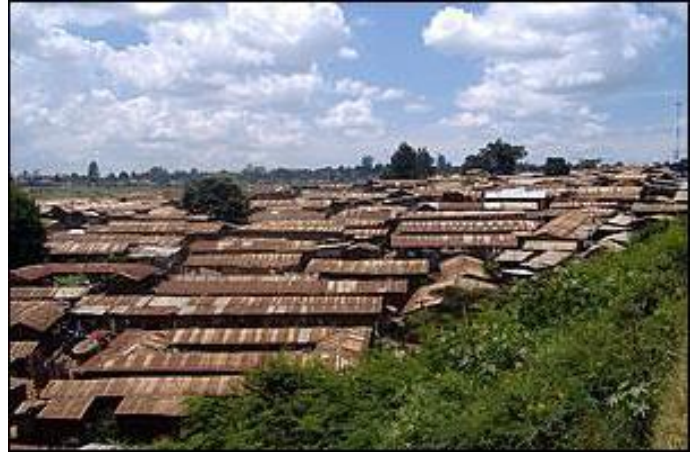
Figure 3. Housing in Kibera informal settlement.

through the Industrial area. Runoff from the impervious surfaces such as iron sheet roofs of the Kibera settlement as shown Figure 3 and the new Ayany Highrise Towers (Figure 4) contribute significant amounts of roof runoff into the river especially during rainstorms. During dry seasons, the amount leaving the dam through the spillway becomes a mere trickle, but when there are heavy rains, it floods. In November 2001, the flow from spillway was measured at $0.2 \text{ m}^3/\text{s}$. These processes result to development of very steep banks or cliffs. Watson and Basher (2006) found that undercutting occurs as a result of redirection and acceleration of flow around obstructions such as debris and vegetation within the channel.

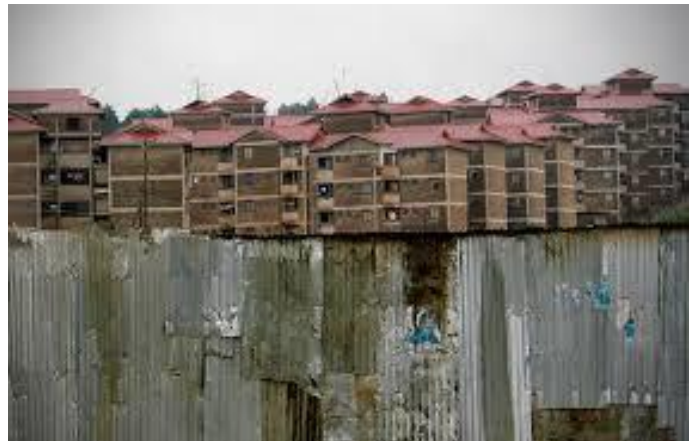
Figure 4. The Ayany Highrise housing scheme in Kibera Area.

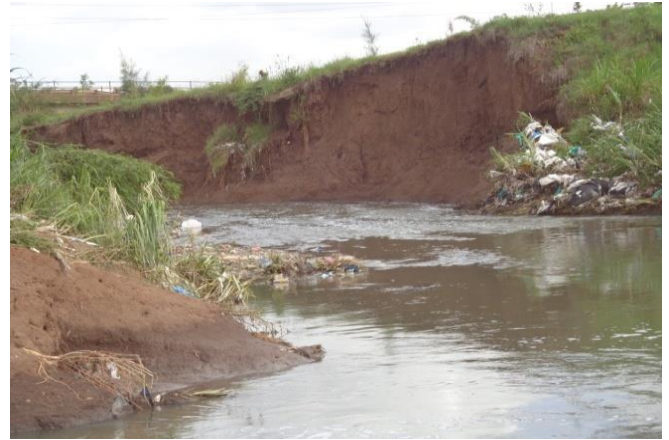
Figure 5. Land slide of high river cliffs. Source: Monene, 2014: Pictures taken on 17/12/13 and 5/9/13.

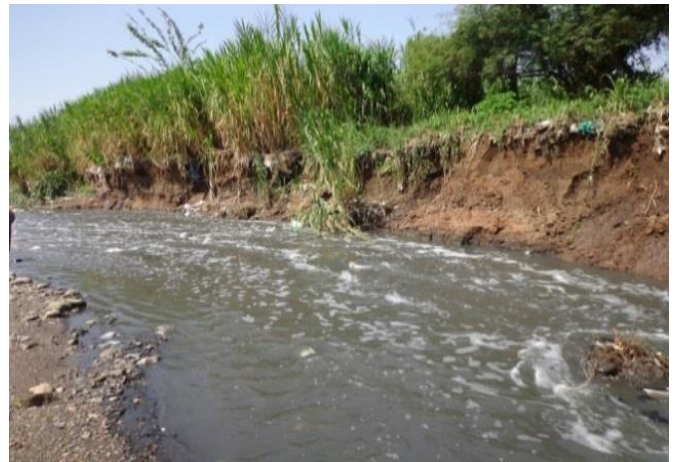
Figure 6. Collapsing of banks. Source: Monene, 2014: Pictures taken on 17/12/13 and 5/9/13.

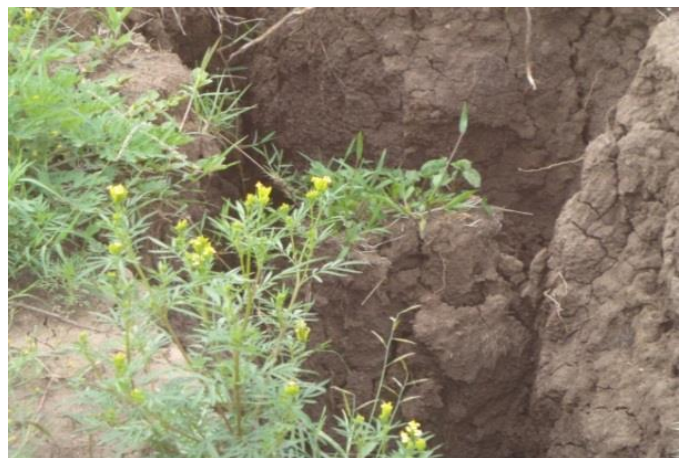
Figure 7. Unstable outer bank showing cracks. Monene, 2014: Photographs were taken 10 m downstream of Kangundo Road Bridge on 17/12/2013.

Decreasing bank resistance to erosion were caused by rapid drawdown of water levels after a rainfall event, consistent lowering of the water table during the dry season, existence of erodible river banks and desiccation of the river bank material. During dry weather the soil loses moisture and contracts. It is during contraction that cracks develop in the soil and subsequently collapse into the river. During the wet season the clay soils absorb moisture and expand. The cracks were on the outer bank

of the river, were about 2 m deep and seemed quite unstable. The collapse of these unstable blocks results to erosion of banks, exposes a new surface to erosion, causes soil loss and supplies sediments to the river.

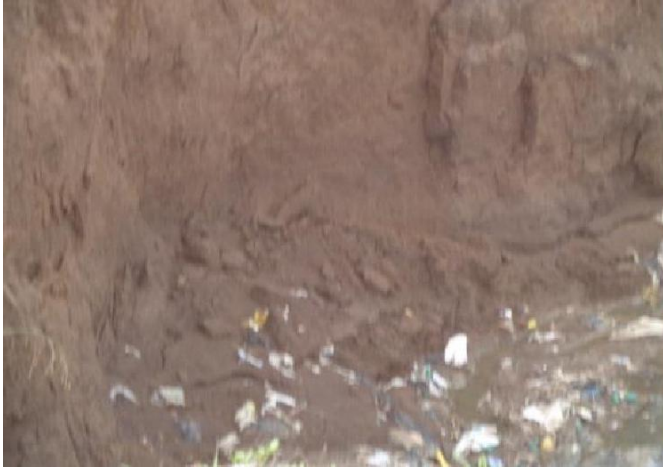
Figure 8. Collapsed outer bank. Monene, 2014: Photographs were taken 10 m downstream of Kangundo Road Bridge on 17/12/2013.

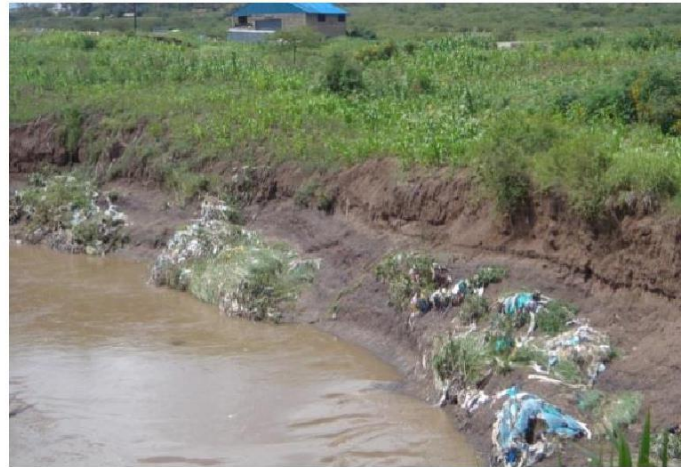
Figure 10. Basal Cleanout of the outer bank. Monene, 2014: Photographs were taken near Kangundo Road Bridge on 28/12/2012.

complex thus combining scour at the bank toe, high pore-water pressure along the bank material and the development of tension cracks at the top of the bank. An accumulation of failed loose blocks that seemed to offer temporary protection to the lower section of the river bank were soon washed away (Figures 9 and 10).

Some points of the river banks portrayed basal cleanout as they had been freshly swept clear of loose soil particles. Direct observation and photography revealed that flash floods had removed supportive and protective bank material, either vegetation or loose soil particles and uprooted vegetation that had colonised the river banks. It was noted that the removal of collapsed bank material left the lower river bank material exposed to a continuous cycle of undercutting, collapse and removal, and the subsequent transportational process thus widening the bank especially during the rainy seasons. Friedman and Lee (2002) found that channel widening was dominant process occurring within hours during infrequent floods.

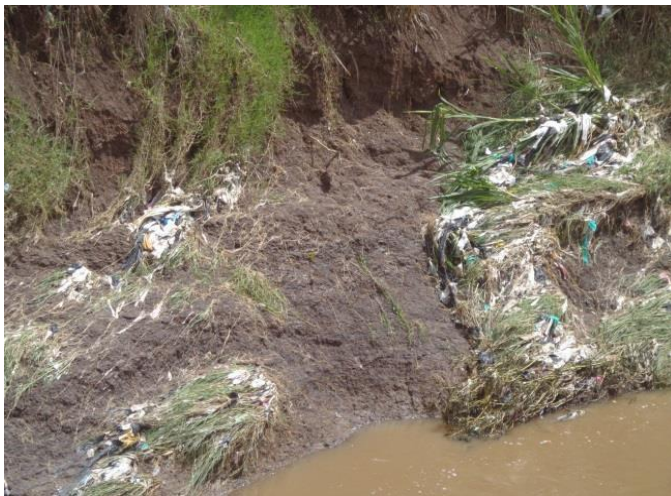
Figure 9. Basal Cleanout of the inner bank. Monene, 2014: Photographs were taken near Kangundo Road Bridge on 28/12/2012.

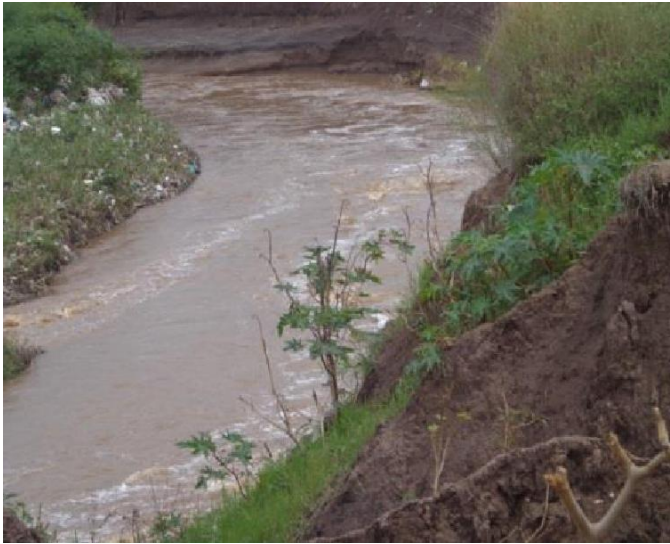
Figure 11. Undercutting of outer bank. Source: Monene 2014: Photos taken on 17/12/2013 during wet season) and 5/9/2013 during dry season.

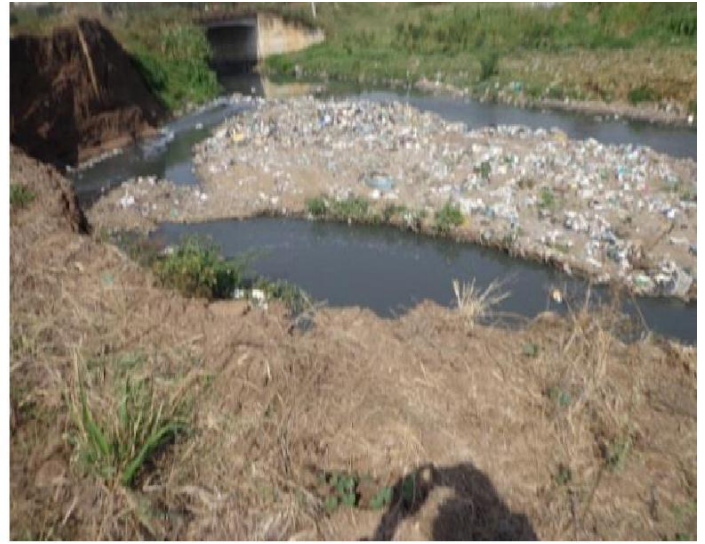
Figure 13. Dry season channel braids.

Channel braiding is a reflection of increased sediment discharge or reduction in discharge and hence sedimentation within the channel. Motoine/Ngong River, downstream the Kangundo road Bridge, has channel bars that get eroded and disappear at high flow stages. The channel is braided downstream the Bridge 2 (Figures 13 and 14). Church and Jones (1982) found that at higher flow stages the largest volumes of sediment are transported and the channels are scoured. During the falling stage maximum deposition occurs as discharge and flow competence are reduced. The channel bed

aggrades and the bar emerges. The channel constriction at the bridge no. 2 after which the water spreads out, channel width increases, and depth decreases. The bar surfaces have vegetation indicative that the bars are stabilizing. The bar separating the channels was larger during the dry season than during the rainy season. The bar disappeared at high flow stages and reformed as discharge fell.

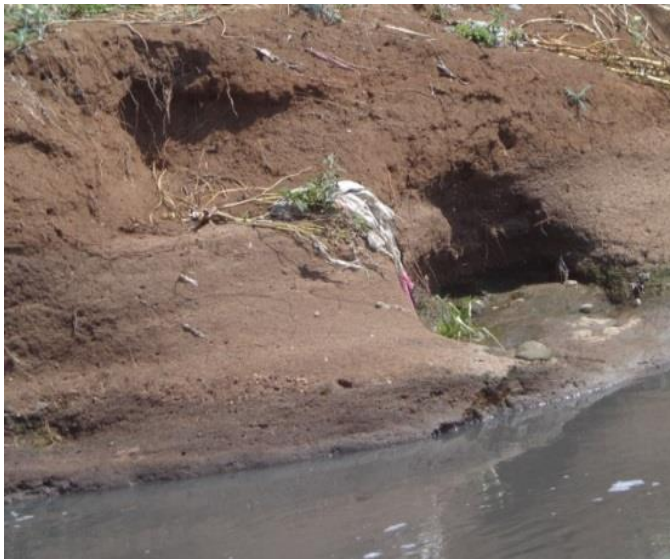
Figure 12. Pop out failure results to cavities. Source: Monene 2014: Photos taken on 17/12/2013 during wet season) and 5/9/2013 during dry season.

additional pressure on the banks. As earlier discussed flow of Motoine/Ngong river varies between seasons and flash floods rise and fall rapidly after a rainfall event. The pore pressure along the river banks caused small to medium sized blocks of fine grained cohesive material to fall out leaving a cavity. The fine cohesive materials allow the buildup of positive pore water pressure and strong seepage within its structure causing the roof of the cavity to collapse resulting to river bank retreat.

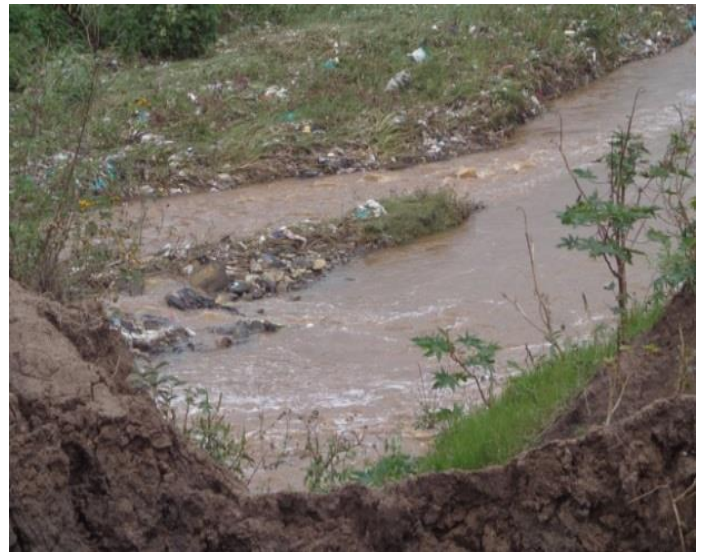
Figure 14. Wet season channel braids.

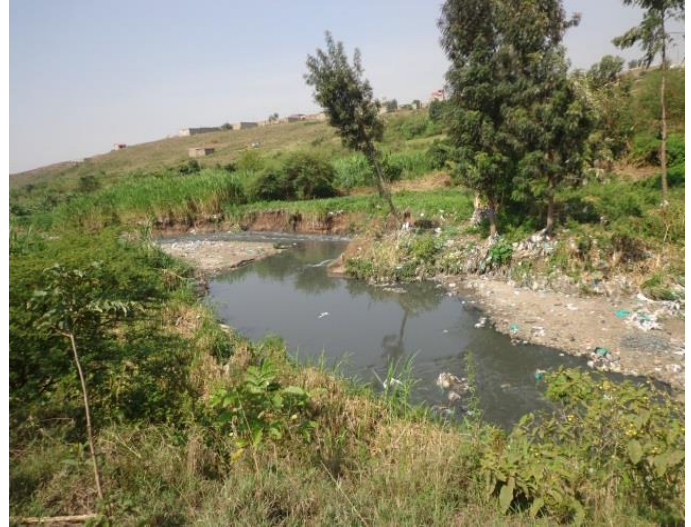
Figure 15. Channel meanders. Monene, 2014: Photos taken on 17/12/2013 and 5/9/2013 respectively.

Previous studies reveal that the processes of bed degradation and lateral erosion destabilize the upper part of the bank (Figure 15). The role of basal erosion is to reshape bank geometry by entraining sediment from the submerged portion of the bank surface when the flow shear stress is greater than the bank resistance force. Basal erosion steepens the bank surface by fluvial undercutting at the bank toe. Consequently, bank failure such as planar, toppling and cantilever, occurs depending on various failure mechanics of cohesive or non-cohesive soil. Outer bank experiences additional pressure caused by the centrifugal force of the current in a bend.

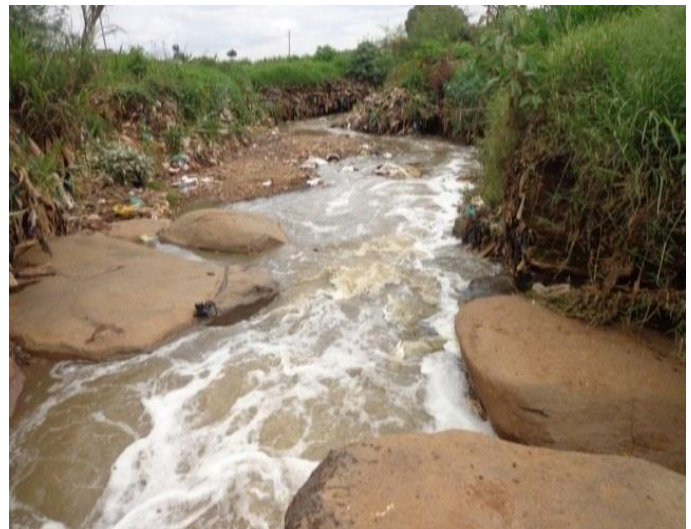
Figure 16. Outcrop rocks near dam inlet. Monene, 2014: Photos taken on 17/12/2013 and 5/9/2013 respectively.

As slope decreases the volcanic rock outcrops emerge showing that further channel incision has been curtailed (Figure 16). In this respect, the appropriate channel response to increased discharge is basically flooding, a feature characteristic of the lower part of the basin.
